**DEPARTMENT OF TRANSPORTATION**

Quality Assurance and Source Inspection

Contract #: 04-0120F4Cty: SF/ALA Rte: 80 PM: 13.2/13.9File #: 69.28**WELDING INSPECTION REPORT****Resident Engineer:**Siegenthaler, Peter**Address:** 333 Burma Road**City:** Oakland, CA 94607**Report No:** WIR-018286**Date Inspected:** 22-Nov-2010**Project Name:** SAS Superstructure**OSM Arrival Time:** 700**Prime Contractor:** American Bridge/Fluor Enterprises, a JV**OSM Departure Time:** 1900**Contractor:** Zhenhua Port Machinery Company, Ltd (ZPMC), Changxing Island **Location:** Shanghai, China**CWI Name:** Zho Zhong Hai**CWI Present:** Yes No**Inspected CWI report:** Yes No N/A**Rod Oven in Use:** Yes No N/A**Electrode to specification:** Yes No N/A**Weld Procedures Followed:** Yes No N/A**Qualified Welders:** Yes No N/A**Verified Joint Fit-up:** Yes No N/A**Approved Drawings:** Yes No N/A**Approved WPS:** Yes No N/A**Delayed / Cancelled:** Yes No N/A**Bridge No:** 34-0006**Component:** OBG COMPONENT**Summary of Items Observed:**

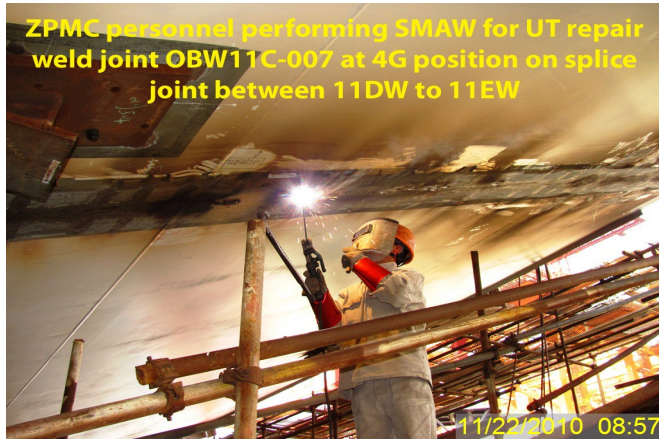
SMAW in the 4G position for the OBG segment 11DW to 11EW, weld No.OBW11C-007.The welder is identified as #040611. ZPMC QC is identified as Mr. Wang Zho. The welding variables recorded by QC appear to comply with WPS-345-SMAW-4G(4F)-FCM-REPAIR-1.The repair report is identified as WR17444.

SMAW in the 4G position for the OBG segment 11DW to 11EW, weld No.OBW11C-008.The welder is identified as #046709. ZPMC QC is identified as Mr. Wang Zho. The welding variables recorded by QC appear to comply with WPS-345-SMAW-4G(4F)-FCM-REPAIR-1.The repair report is identified as WR17471.

data sheet according to rejection criteria of “D” Scan procedure that Caltrans QA and ABF QA have jointly filled out on this date. The QA inspector found no rejectable indication at scanned area.
